MEETING AGENDA
Stormont, Dundas and Glengarry County Library Board

ACTION REQUEST

SUBJECT: Williamstown Branch

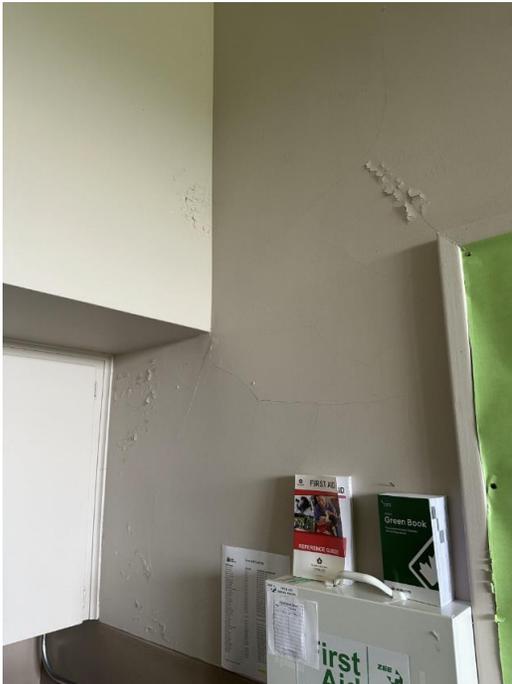
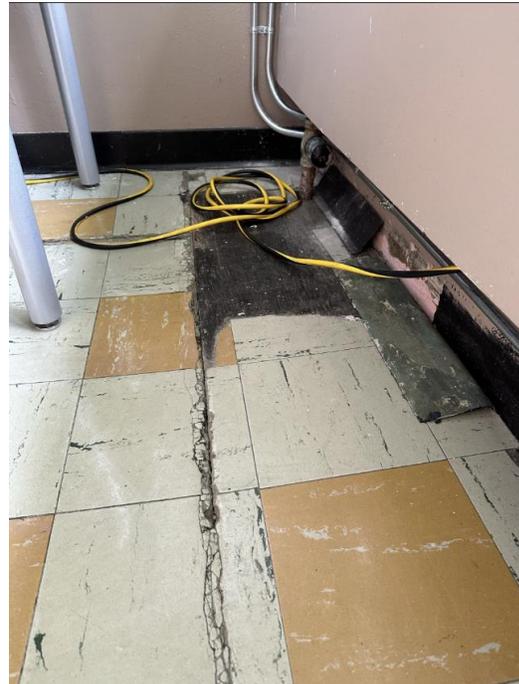
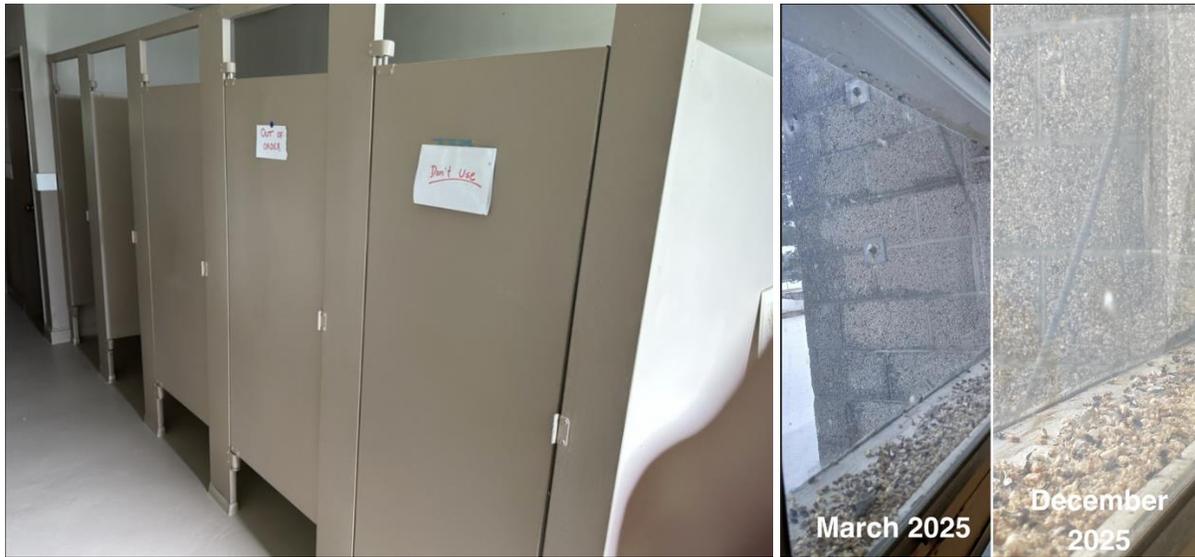
1. St. Mary's Centre, likely constructed sometime between 1940 and 1960, serves as a community hall and hosts the Williamstown branch.
2. Over the years, several facility deficiencies have been noted, including lack of central air, windows that either cannot be opened or do not have screen, dead bugs and condensation between windowpanes, damaged floor tiles, evidence of water damage on ceiling tiles, peeling paint, a general musty smell, evidence of rodents, evidence of mould in the bathroom, granular parking lot with pot holes, and lack of accessibility in the washrooms.

7. Although the DSR has not yet been received, the SDG Library has been in regular contact with the consultant. The set of bulk sampling results indicate no asbestos within the tile mastic, acoustic ceiling tile and countertop, while the vinyl floor tile, for the blue and red tiles, returned as 6% and 8% chrysotile asbestos respectively. Precautionary sampling returned fibre concentrations below 0.05 f/cc, which is considered acceptable

8. The asbestos-containing vinyl floor tiles are considered a non-friable material. Non-friable materials have little potential to release airborne fibres, even when damaged by mechanical breakage, but can become friable if disturbed by drilling or abrading. This, coupled with the TEM air sampling results, demonstrates that walking on or in the area of non-friable vinyl floor tiles does not pose a risk to the occupants even in a damaged state.

9. In terms of best practices, vinyl floor tiles that have broken should be removed to maintain the Good Condition of the asbestos-containing material (ACM). Disposal of asbestos-containing materials needs to be completed by a licensed abatement contractor.

10. It is not recommended to install new flooring without having the poor condition/damaged tiles removed. All floor tiles should be in good condition before replacing or covering with a new floor.
